**Report on the Use of Aerial Photographs for  
Identifying Wetland Permit Violations**

Northern Virginia Planning District Commission

September, 1992

**1992  
Low Altitude Aerial Photographs  
of the  
Northern Virginia Potomac River Shoreline**

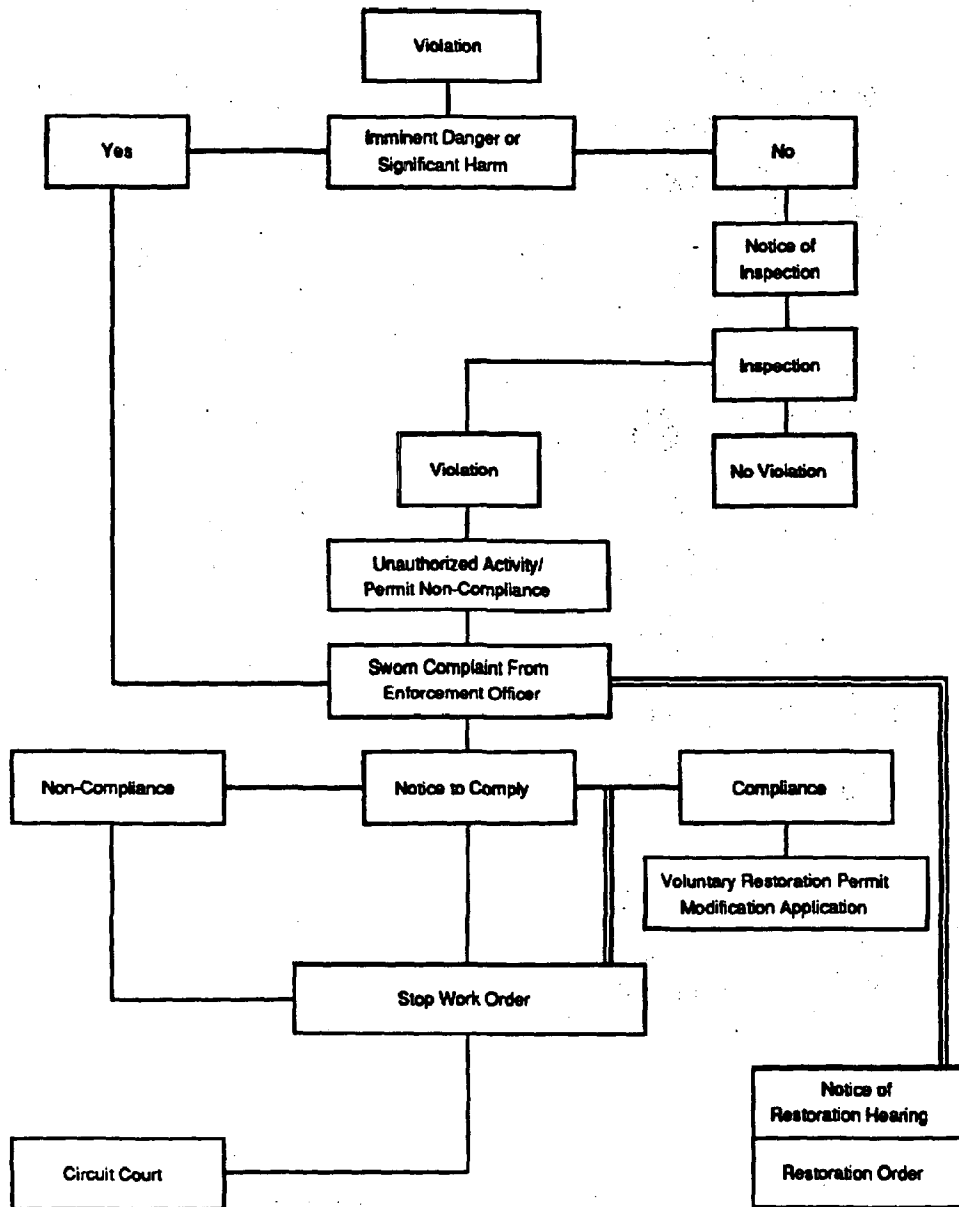
**Figure 1 - Enforcement Procedures**

Enforcement procedures within Virginia's 32 wetland boards has in the past reflected the varying degrees of complexity found in each local government. Figure 1 represents a generalized flowchart, by the Virginia Marine Resources Commission, outlining the enforcement component incorporated into the Code of Virginia regulations for subaqueous lands, tidal wetlands and sand dunes. The components provide a basis from which localities can refine an enforcement mechanism, which is legally complete and reflects the unique character of each locality. The enforcement flowchart identifies two available paths for invoking civil penalties or charges. Both paths involve identifying the presence of a violation. Once a violation has been determined and documented sufficiently, a Sworm Complaint is issued, followed by a Notice to Comply. In cases where restoration is a desirable conclusion, the individual has the option of restoring an area to pre-existing conditions. Otherwise, application for a permit modification or after-the-fact approval is necessary.

In the absence of complete and satisfactory restoration, anyone found in violation of these Code sections is subject to either a civil penalty (Circuit Court) or to a Civil Charge (local wetlands board). In Circuit Court, a judge can levy a civil penalty up to \$25,000 for each day of violation. The Commission and wetlands boards may assess civil charges of up to \$10,000 per violation, which are to be paid in lieu of any appropriate civil penalty and can be assessed only with the consent of the person in violation. The obvious intent of both civil penalties and charges is to provide financial disincentives against violating the law, while at the same time providing the impetus to resolve these issues at an administrative level.
